PROJECT
Hampton Inn Owen Sound
750 16th Ave E

Free Protection Plan

SHEET
Landscape Concept

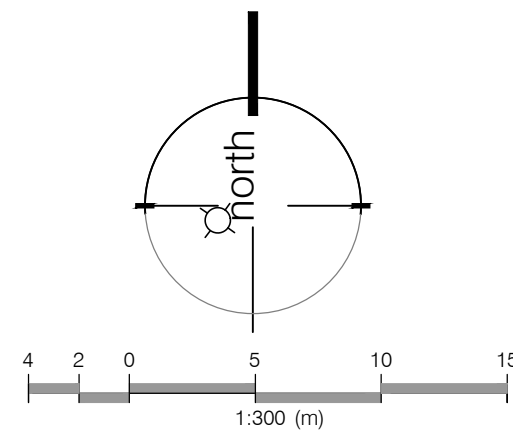
L-1

Tree #	Species (Common Name)	Species (Botanical Name)	DBH (cm)	Crown Class*	Condition**	Crown Width (m)	Comments	Potential Impacts from Construction	Ownership (Trees were not surveyed; all trees are field located)	Recommendation
1	Colorado Blue Spruce	Picea pungens	34	D	Fair	2.85	Some damage due to branches being cut for adjacent overhead wires and pruning at base		Neighbouring (Private)	Save
2	American Elm	Ulmus americana	38	D	Good	4		Conflict with proposed driveway entrance	Private (within future road widening)	Remove
3	American Elm	Ulmus americana	26	CD	Fair	2.3	Uneven canopy	Grading within rootzone for multi-use path and regrading of roadside ditch	Private (within future road widening)	Remove
4	American Elm	Ulmus americana	21	CD	Fair	1.5	Uneven canopy	Grading within rootzone for multi-use path and regrading of roadside ditch	Municipal	Remove
5	American Elm	Ulmus americana	15	S	Fair	1.5	Uneven canopy	Grading within rootzone for multi-use path and regrading of roadside ditch	Municipal	Remove

6	American Elm	Ulmus americana	17, 12, 24, 22	CD	Fair	3.5	Trunk splits at base	Grading within rootzone for multi-use path and regrading of roadside ditch	Boundary (Municipal)	Remove
7	American Elm	Ulmus americana	17	D	Poor/Dying	2	Tree is in poor condition, dead branches	Grading within rootzone for multi-use path and regrading of roadside ditch	Boundary (Municipal)	Remove
8	American Elm	Ulmus americana	14	CD	Fair	2.5	Some damage to canopy, some dead branches	Grading within rootzone for multi-use path and regrading of roadside ditch	Municipal	Remove
9	American Elm	Ulmus americana	13	CD	Fair	1.6	Uneven canopy	Grading within rootzone for multi-use path and regrading of roadside ditch	Municipal	Remove
10	American Elm	Ulmus americana	17	CD	Fair	1.6	Uneven canopy	Grading within rootzone for multi-use path and regrading of roadside ditch	Municipal	Remove
Shrub #	Species (Common Name)	Species (Botanical Name)	Spread (m)	Height (m)			Comments	Potential Impacts from Construction	Ownership (Shrubs were not surveyed; all shrubs are field located)	Recommendation

11	Common Buckthorn	Rhamnus cathartica	1.5	2			Invasive species	Conflict with proposed parking lot	Private	Remove
12	Common Buckthorn	Rhamnus cathartica	2.4	4			Invasive species	Invasive species to be removed	Municipal	Remove
13	Dogwood	Cornus sp.	1.87	2.2				Invasive species to be removed	Private (within future road widening)	Remove
14	Common Buckthorn	Rhamnus cathartica	2.95	4.5			Invasive species	Invasive species to be removed	Private (within future road widening)	Remove
15	Common Buckthorn	Rhamnus cathartica	2	2			Invasive species	Invasive species to be removed	Municipal	Remove
16	Common Buckthorn	Rhamnus cathartica	1.5	2.5			Invasive species	Invasive species to be removed	Private (within future road widening)	Remove
17	Common Buckthorn	Rhamnus cathartica	5	4			Invasive species	Invasive species to be removed	Private (within future road widening)	Remove
18	Common Buckthorn	Rhamnus cathartica	1.5	1.5			Invasive species	Invasive species to be removed	Private (within future road widening)	Remove

19	Common Buckthorn	Rhamnus cathartica	1.75	3.5			Invasive species	Invasive species to be removed	Private (within future road widening)	Remove
20	Common Buckthorn	Rhamnus cathartica	2	3			Invasive species	Invasive species to be removed	Private (within future road widening)	Remove
UNIT 1	Common buckthorn	Rhamnus cathartica		4			Invasive species, 3-4 shrubs	Invasive species to be removed	Municipal	Remove
UNIT 2	Common buckthorn	Rhamnus cathartica		4			Invasive species	Invasive species to be removed	Municipal	Remove
UNIT 3	Common buckthorn	Rhamnus cathartica		3			Invasive species	Invasive species to be removed	Municipal	Remove

CONDITION OF TREES
The decision to remove or retain a tree is subject to the forecasted development impacts, the structural condition of the tree (e.g. cracks, cavities, decay, weak branching, leaning, hazard potential), the biological condition of the tree (e.g. pest or disease concerns, overall health) and the suitability of the tree in its location (e.g. hardness, soil conditions, salt tolerance, visual obstruction, available soil volume)
